Oversight News

Newsletter of the Commonwealth’s Environmental Oversight of the Paducah Gaseous Diffusion Plant

Work to Control Contaminated Sediments Begins

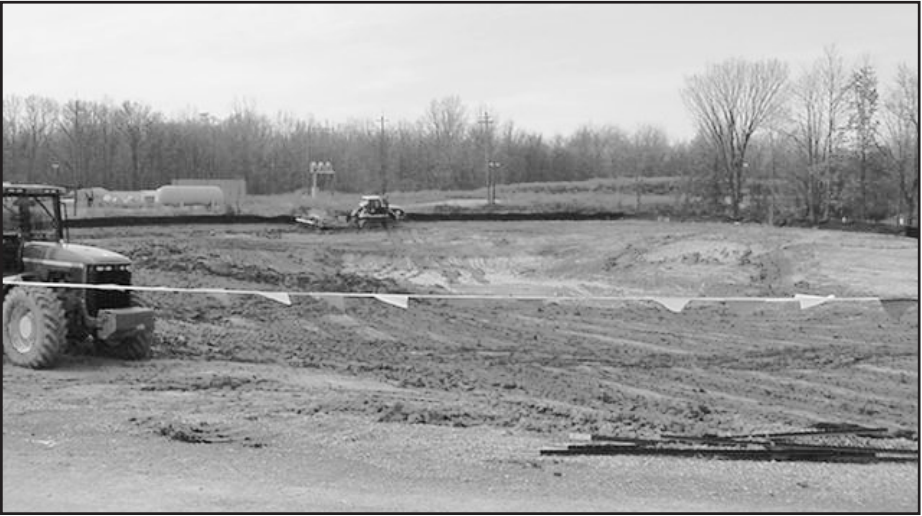
Construction of the northwest corner sedimentation basin began in December.
Photo courtesy of **Gaye Brewer**, KY Division of Waste Management

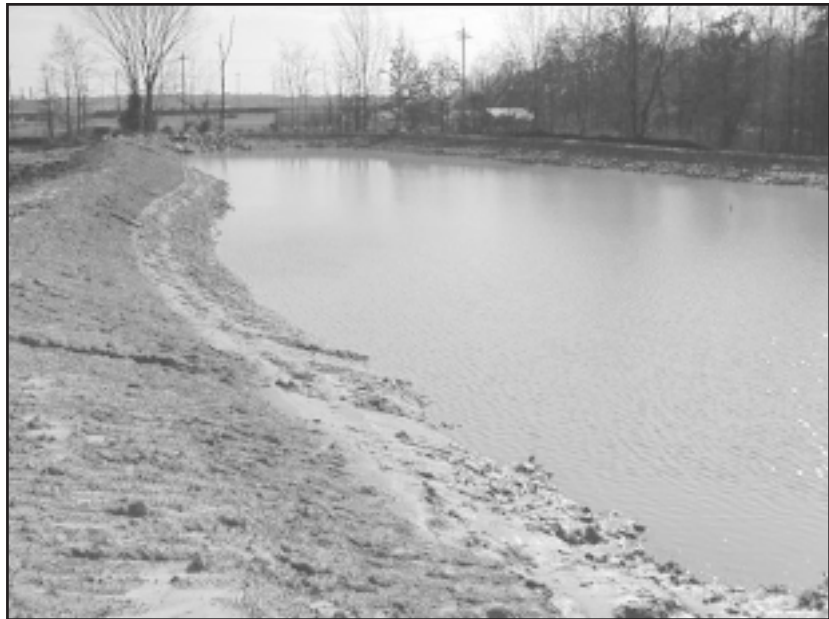
The northwest corner basin will prevent the spread of contaminants transported by storm runoff while scrap metal removal takes place.
Photo courtesy of **Gaye Brewer**, KY Division of Waste Management

Regulators required that storm water runoff controls be in place before removal of the rest of the scrap metal. Accordingly, DOE submitted plans for the northwest corner sedimentation basin. In September, regulators approved the design of the basin, which will prevent the migration of contaminated sediments from the scrap yards to off-site areas while

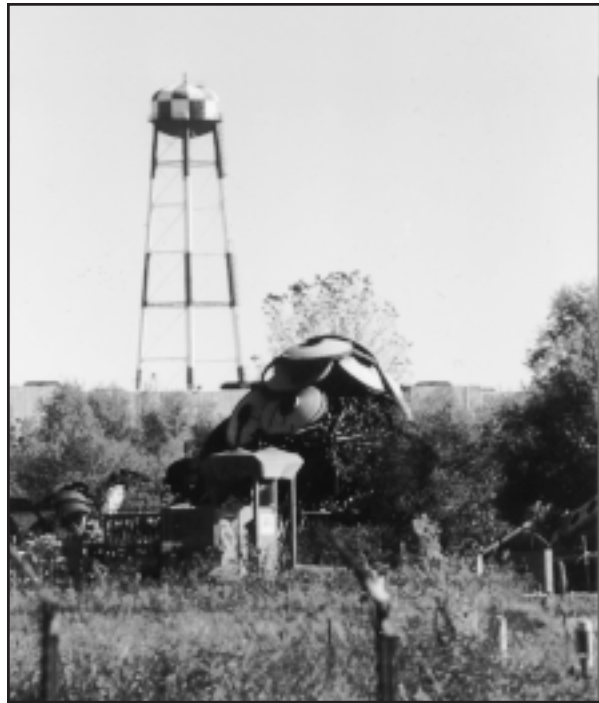
The scrap metal removal project will include eight scrap yards located in the northwest corner of the plant.
Photo courtesy of **Todd Hendricks**, KY Division of Waste Management

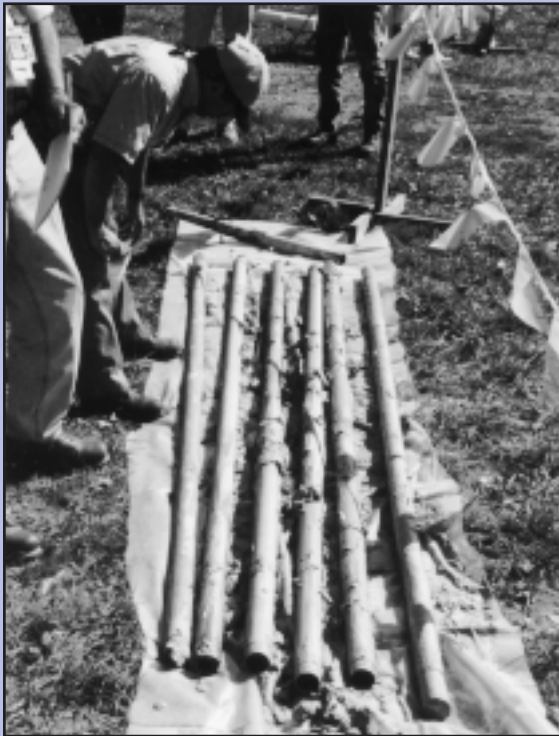
During the past year numerous corroded stainless steel monitoring wells have been identified at the Paducah Gaseous Diffusion Plant (PGDP) site. While the cause of the corrosion remains somewhat a mystery, microbes (bacteria) may play a large role. Another suspected cause is the flow of subsurface electrical currents in and out of the well casings. Whatever the reason, the result is a corroded monitoring well casing that in many instances must be replaced.

Nearly all of the monitoring wells that comprise the monitoring systems for the C-746-S, -T and -U landfills show

DOE contractors examine monitoring well casings for signs of corrosion.
Photo courtesy of **Todd Hendricks**, KY Division of Waste Management

evidence of corrosion and will therefore need to be abandoned. The Department of Energy has submitted work plans to the Kentucky Division of Waste Management that describe the details behind this large-scale well replacement effort. All wells designated for abandonment will be replaced with wells constructed using corrosion-resistant PVC casing materials.
